Austin Seven Steering Arms

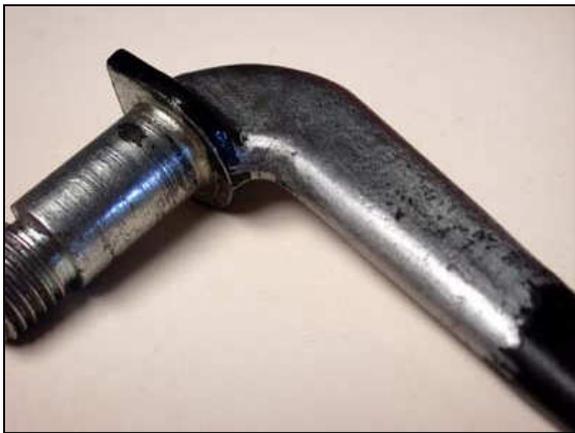
Cracked steering arm

Towards the end of 2002 I became aware that the topic of replacement steering arms was cropping up fairly frequently in magazines and on the internet. As is often the case, there was quite a lot of chat but very little action! Talking to various people made me realise that the problem was rather more serious than first thought; none of the usual suppliers were selling these arms, and the stockists of used spares were finding it very difficult to get hold of any that weren't cracked. Wayne Rushin (Midshire Sevens) and Tony Betts (County Sevens) were most helpful, and examined several batches of steering arms which came through their hands. They managed to crack test a total of about 60 arms, and found that the average failure rate (i.e. cracks present) was around 70-80%. A typical cracked arm is shown below:

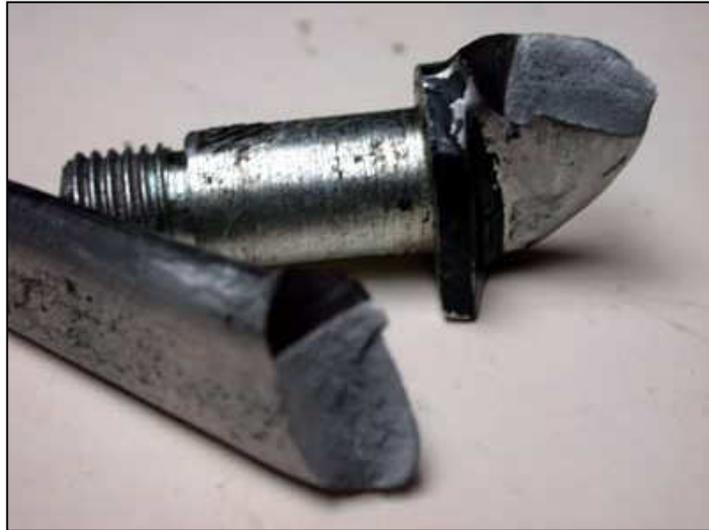
Broken steering arm (Bruce White)

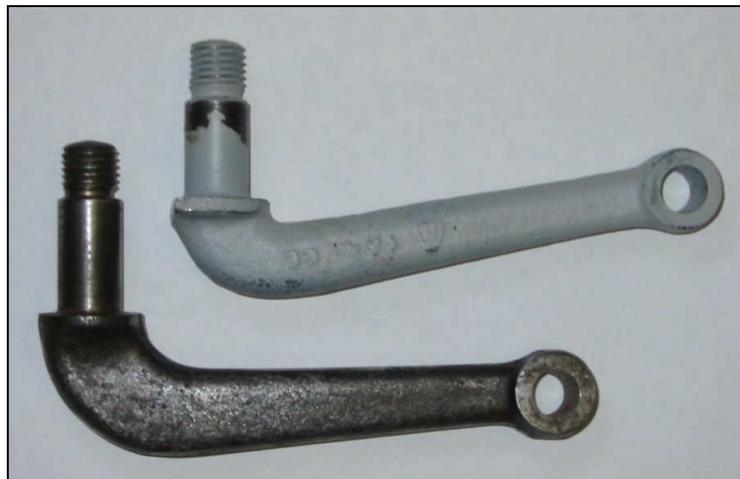
Standard Austin 7 arm (top) compared with Big 7 arm (Hartham Technology)

Looking at the various arms produced by Austin over the years showed that there had not been any significant redesign until the Big Seven came along. This arm is much heavier and the radius of the bend is not so severe, but there are several other differences: it has no flat on the flange, there is a keyway on the shaft, and the arm does not curve back as far as the earlier type. However, to my knowledge, none of this type has ever been known to fail, so it was decided to use this arm as the basis for the new ones. It seemed justifiable, in this case, to break from usual practice and make these parts to a later design.

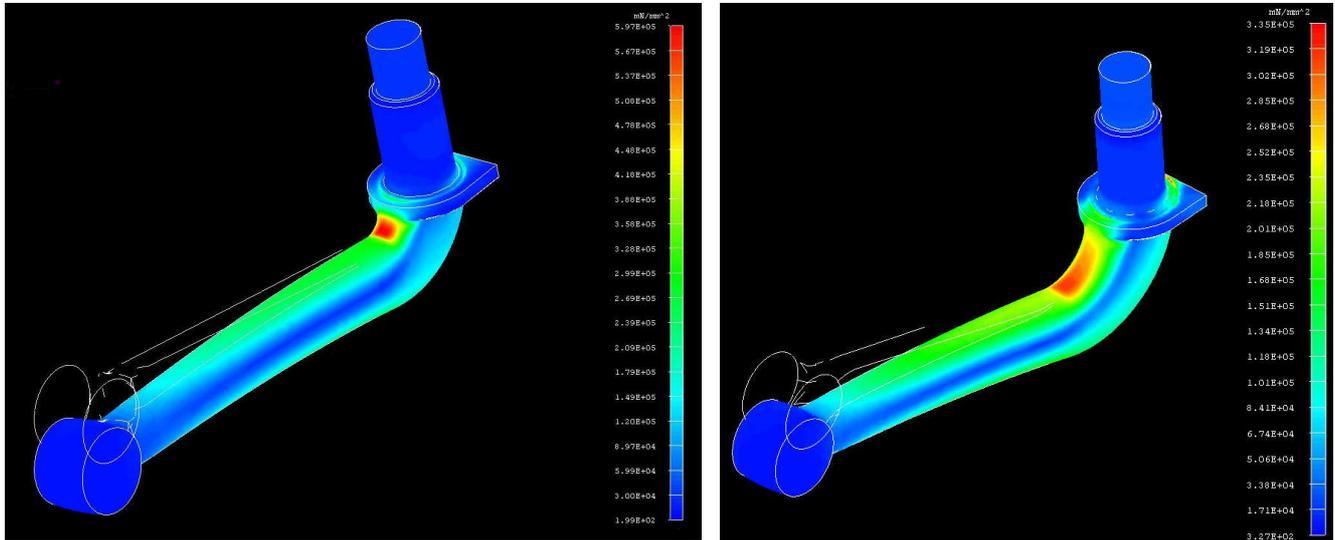
They produced a very comprehensive report, which included finite element model generation, analysis, results and life estimates. They also provided drawings, manufacturing recommendations and advice on material selection for the re-designed steering arm. The stress distribution in the bend for the original and redesigned arms is shown, from which it can be seen that the maximum stress is much lower than before, as well as being far less concentrated (the peak stress denoted by the red in the right picture is about half the value of the peak stress denoted by the red in the left picture).

The overall improvement in life of the re-designed arm is significant. From the stress results calculated by finite element analysis, it can be shown that the life has increased from several thousand to several million cycles (assuming an indicative loading for comparison purposes – this does not give the actual life). For instance, looking only at the stress in the bend, under the assumed loading conditions the original arm would fail in this region after approximately 6 thousand cycles. With the re-designed arm there is a reduction in stress of 48% and this effectively takes the stress below the recommended endurance limit for EN16B steel. Hence the life is likely to be greater than 10 million cycles (at the indicative loading). Whatever the actual loads, this represents a large increase in the life of the steering arm at this location.

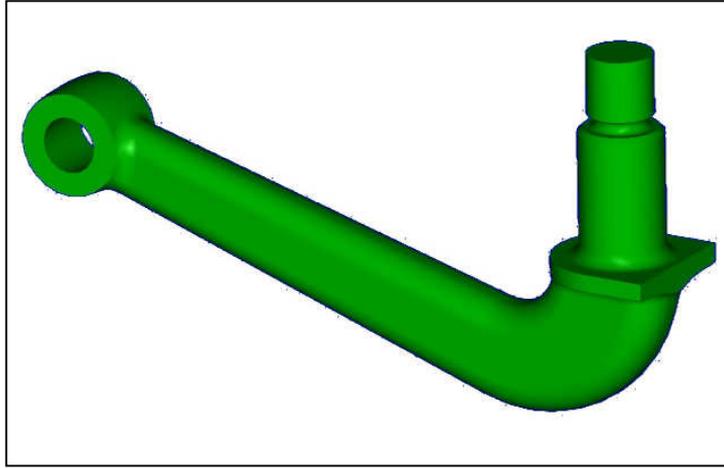
Re-designed arm. Note also the increased corner radius where the shaft meets the flange.
